SNAG REPORT

# 14 Oak Lane, Naas, Co. Kildare

Inspected 19 October 2026

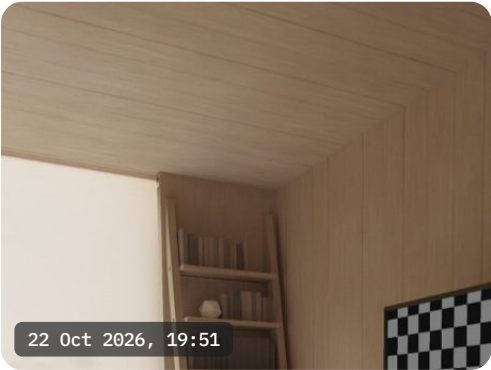
1.1

Open MINOR

**Crack in plaster above window**

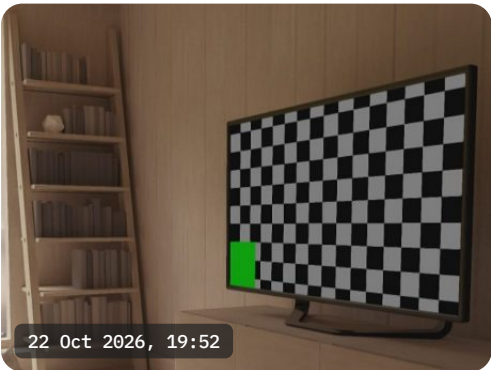
1.2

Open MINOR

**Paint splashes on skirting**

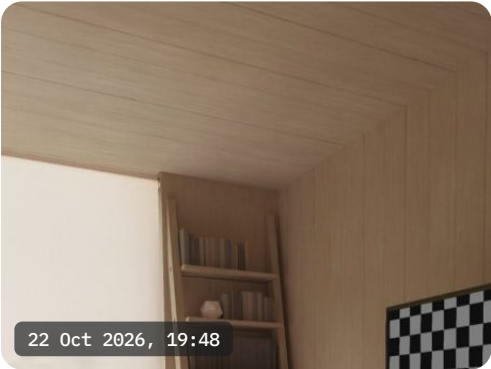
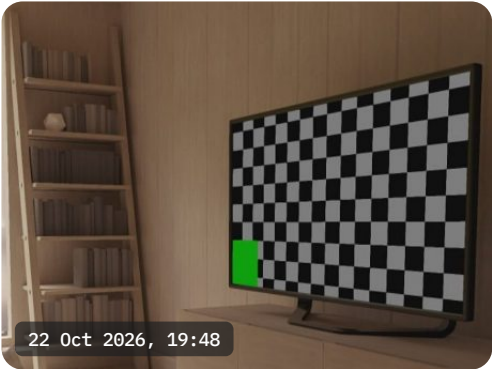
Open MAJOR

2.1 Worktop chipped at sink cut-out

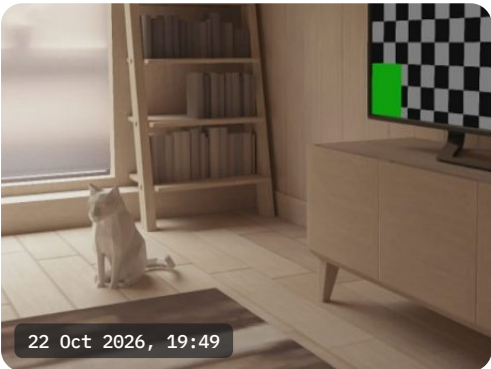
Open MINOR

2.2 Unit door misaligned

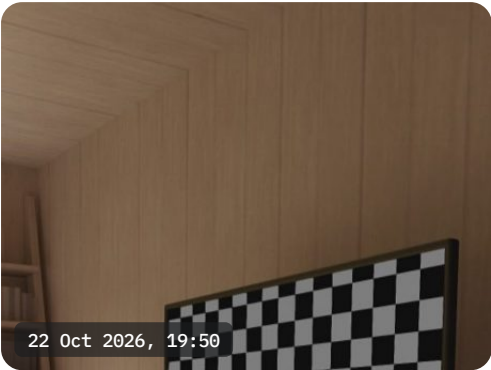
Fixed MINOR

2.3 Gap in sealant behind hob

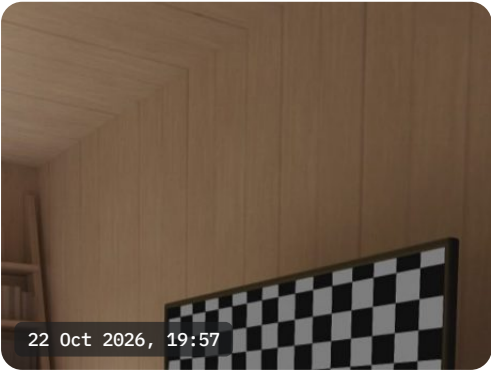
3.1

MAJOR

Washing machine waste not connected
